Geotechnical investigation and slope stability analysis of Kallarkutty earth slide, Idukki District, Kerala, South India

^{a,b,c} Geological Survey of India

ABSTRACT

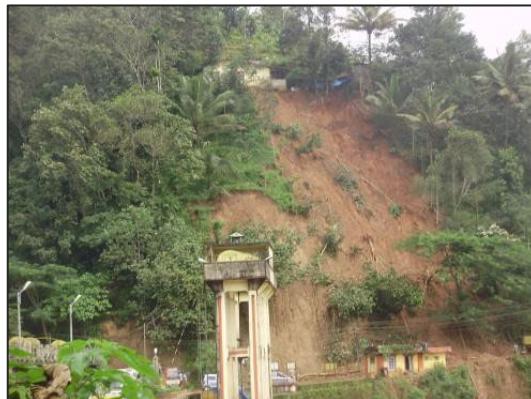
Two earth slides occurred at Kallarkutty (Fig. 1). The first slide, located at Kallarkutty Junction, measured approximately 40 m in length, 20 m in width, 2 m in depth, and had a height of about 35 m (Fig. 2). The second slide, situated northwest of the dam, had dimensions of approximately 15 m length, 15 m width, 0.5 m depth, and a height of around 10 m (Figs. 3 & 4). These incidents resulted in the development of cracks and sub-cracks extending approximately 50 m in length and 0.3 m in width behind the crown portion (Fig. 5). These cracks appeared both on the ground surface and in nearby buildings (Fig. 6). Another landslide occurred north of these incidents, measuring about 10 m in length, 10 m in width, 0.5 m in depth, and with a height of approximately 7 m. The failure mechanism of these landslides is primarily of the shallow translational type (BIS,1998).

Fig.2 Landslide occurred on 06-08-2013 towards south of the Kallarkutty junction.

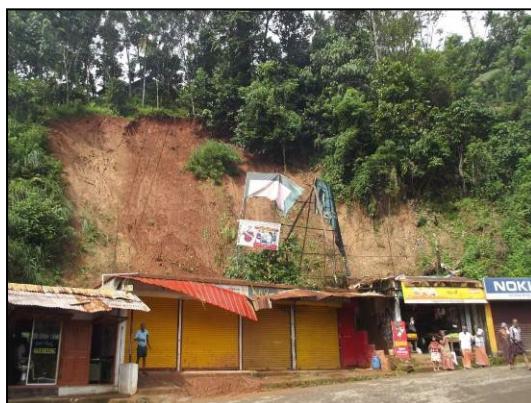
Fig. 3 Landslide occurred on 05-08-2013 at the Kallarkutty junction

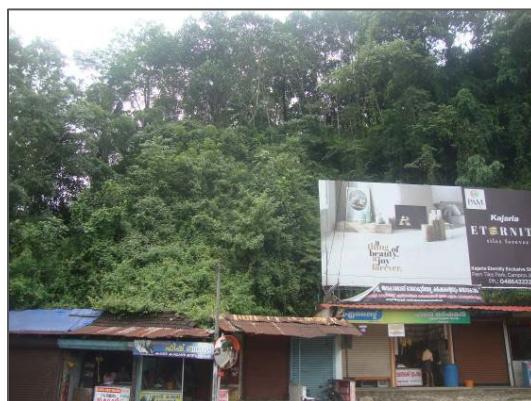
Fig. 4 Status of Landslide location of fig.3 as observed in 2017

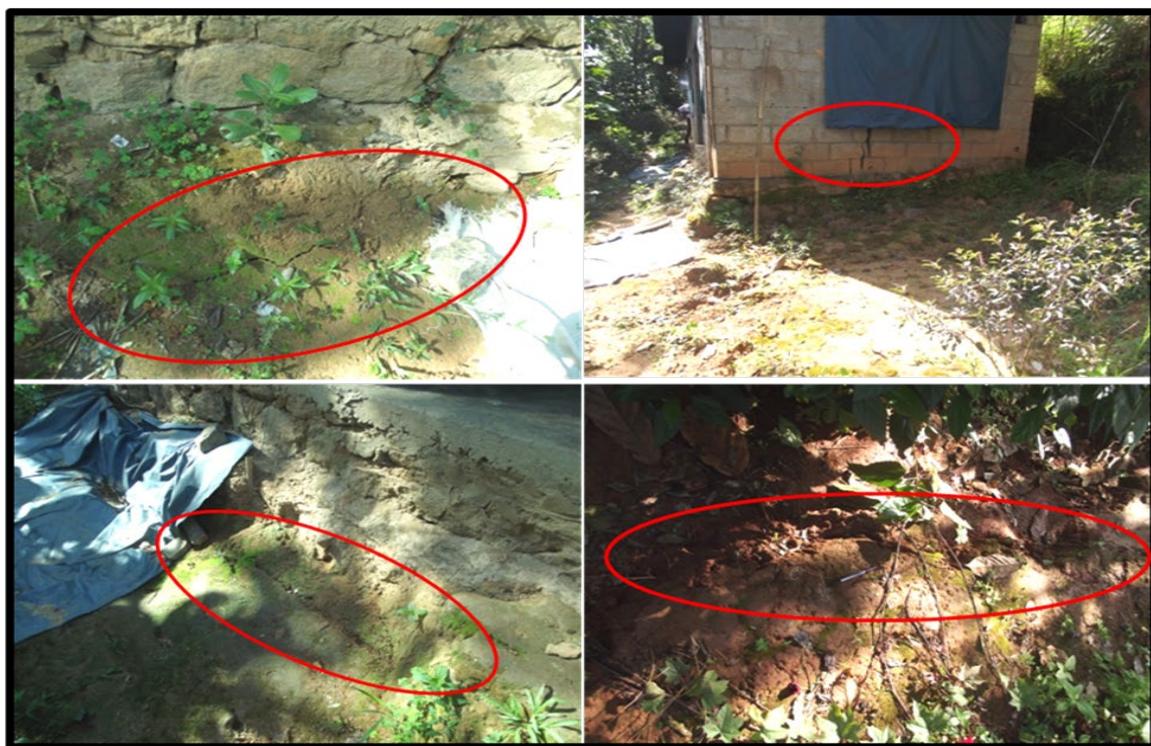
Fig. 5 Different segment of cracks developed near the crown of the landslide occurred at Kallarkutty junction

Besides, the extensive cutting and un-supported vertical cut surface which is made unscientifically along the cliff edge for the construction of road and commercial buildings, made the slope more unsafe which resulted in landslide incidences. The crown cracks developed in the area indicates the retrogressive nature of the landslide and if a slope failure occurs in future, the soil material in the downslope side may enhance the intensity of damage in this area.

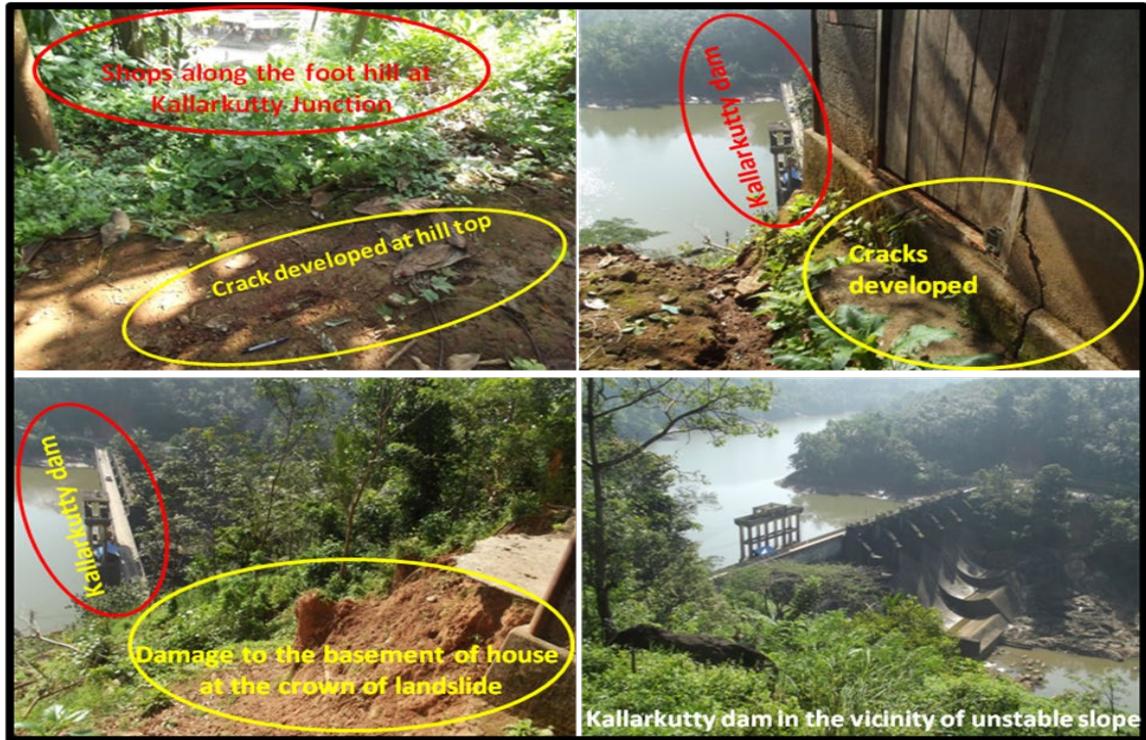
Fig. 6 Impact of landslide occurred on 5th and 6th of August 2013 at Kallarkutty junction

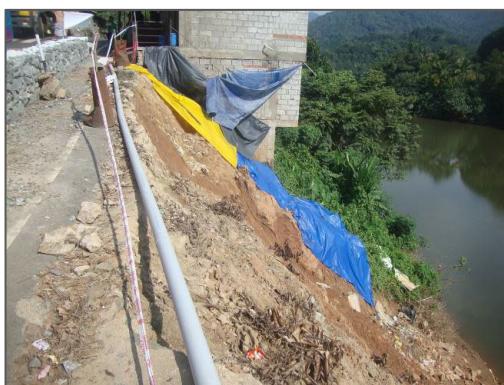
The area also witnessed two landslides including one reservoir bank failure on 19th September 2017 (Figs. 7 & 8). The length, width and depth of the reservoir bank slide are ~10 m, ~15 m and ~2 m respectively. Three shops were damaged during the failure. The nature of distressed material shows that the soil in the area is very loose and moist.

Fig. 7 Bank failure occurred between the road and reservoir on 19th Sep., 2017

Slope stability analysis suggests that FoS values decreases with saturation and towards downslope side at the cliff edge, FoS values are less and hence unstable. The increase in soil thickness and the extensive cutting with unsupported vertical cut surfaces made the cliff edge more unsafe which may attribute landslide incidences in future. The following corrective measures are suggested based on the study: (i) Easing of the slope at the vertical cliff edge (ii) Retaining wall / gabion wall with proper drain holes may be provided at the base/toe of the slided slope (iii) Slope above the retaining wall / gabion wall may be dressed and turfed (iv) Filling of the cracks in the crown area with impervious clay or bitumen (v) Catch water drains or chute drains may be provided above the crown of the landslide to divert or channelize the water away from the slided area. (vi) Strengthening of the filled slope at the slided road side by constructing proper retaining structure from the base of the reservoir to the road level to avoid reservoir bank failure. To

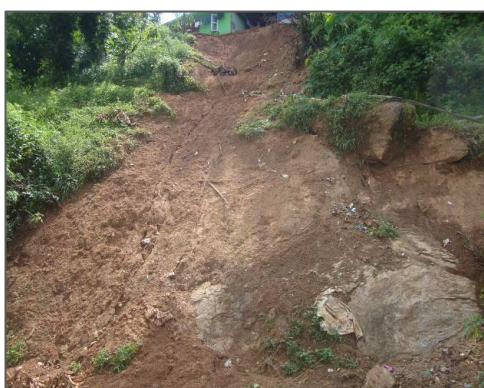
Fig. 8 Earth slide occurred on 19th Sep., 2017. Rock overburden contact is exposed

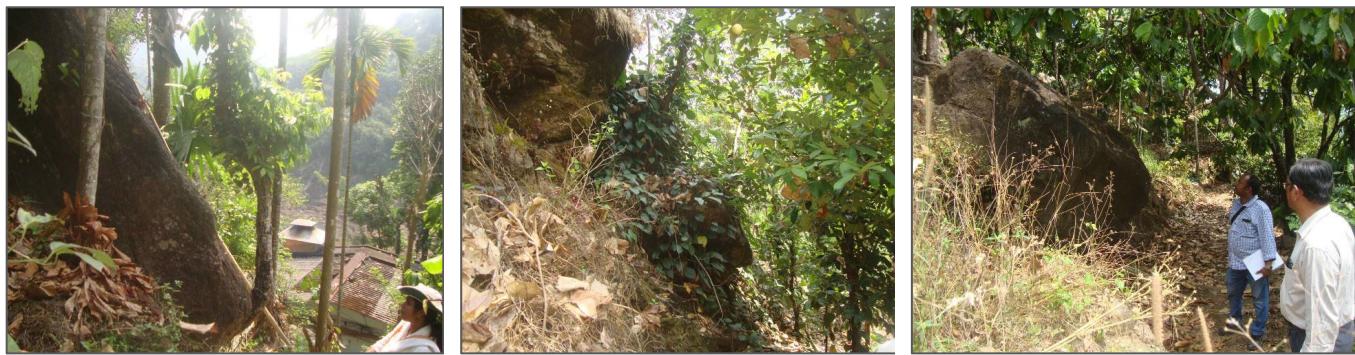
Fig. 9 Precarious boulders seen at the mid slopes

The recurring earth slides occurred at Kallarkutty hill slope is a threat to the commercial establishments and houses located at the foothills. The unscientific constructions blocking the natural drainage and ignoring the precarious boulders along the hill slopes which are threat to the dwelling units. The preparatory factors for the landslide to occur are mainly the removal of toe support and unscientific slope modification without support intervention by excavation through overburden material rich in lithomarge, whereas pore pressure increment aided by heavy rainfall is the triggering factor.

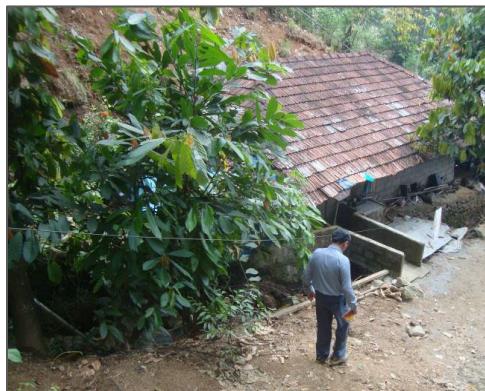
Hornblende biotite gneiss/composite gneiss, biotite gneiss and migmatized gneiss are the country rocks (Geological and Mineral map of Kerala, 1995; Anil Kumar et al., 1984; Nair and Anil Kumar, 1990; Thampi et al., 1979, 1980) in the area. Hard rock formations (HBG/BG) are intermittently exposed along road sections and upslope areas of the hill. The hornblende biotite gneiss exhibits a foliation trend of N 50° W – S 50° E, dipping at 56° NE. The area features moderate to steep slopes, often modified for terrace farming and vertical cuts for house construction. Overburden materials consist mainly of clayey lateritic soil, lithomarge, and saprolite, typically reddish brown to greyish black, fine to medium grained, humus-rich, and moderately sorted. Near the upslope side, hard rock is shallow (<3 m depth), with weathered material starting around 50 cm depth. There are precarious boulders behind houses, some exceeding 10 m in diameter and supported by trees, posing a constant threat (Fig. 9). The largest boulders measure 2x5x5.5 m, 2x4x5 m, 4x3x1.5 m, and 5x3x2 m. A house constructed within a first-order stream on the downslope side obstructs water flow (Fig. 10)

Fig. 10 A house in the first order stream

- (i) Unscientific road construction / widening should be avoided
- (ii) Houses/buildings constructed on the nala path located in the northern portion of the study area may be evacuated and further construction should not be allowed in such locations and natural drainage system may be preserved without obstructing the flow of natural streams
- (iii) People staying just above the road cut at the cliff edge may be evacuated during incessant rainfall
- (iv) Waterlogging condition along the vulnerable slopes has to be avoided
- (v) Precarious boulders lying on the hill slope are to be removed/ supported and
- (vi) People should be educated about the ill-effects of unscientific slope modifications to avoid slope failures in future.

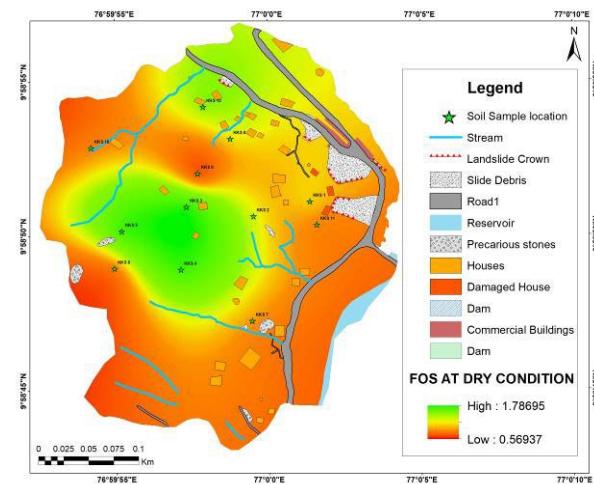
Variation in ground water which controls the pore pressure is the important factor in the factor of safety. Due to the difficulty of modeling ground water variation or fluctuation in hill slopes, five scenarios have been used to calculate the factor of safety viz., (a) considering zero pore pressure ($Z_w = 0$), (b) considering 25% pore pressure ($Z_w = Z/0.25$), (c) considering 50% pore pressure ($Z_w = Z/0.50$), (d) considering 75% pore pressure ($Z_w = Z/0.75$) and (e) considering maximum pore pressure ($Z_w = Z$) i.e., complete saturation. The FoS under different saturated slope conditions are given below (Table 2) and the plots were prepared based on the FoS value at dry condition, 50% saturation and 100% saturation (Figs. 17 to 19). Spline with barrier technique in ArcGIS is adopted to generate 2D pictorial representation of FOS, using the equation for the infinite slope stability analysis model $FoS = FoS_{friction} + FoS_{cohesion} - FoS_{pore\ pressure}$. The derived results indicate $FoS < 0.8$ is highly unstable, FoS 0.8 to 1 is unstable, FoS 1 to 1.2 is stable and $FoS > 1.2$ is very stable. The FoS values in the present study area varies from 0.569 (Red) to 1.787 (Green) under the dry condition (Fig. 17), 0.463 (Red) to 1.444 (Green) under 50% saturation (Fig. 18) and 0.357 (Red) to 1.101 (Green) under 100% saturation (Fig. 19). The FoS value in the uphill side is relatively higher and this is mainly due to the less thickness of soil/overburden and the low degree of slope. At the cliff edge, the soil thickness is more and hence the FoS value is decreasing.

Fig. 17 Factor of Safety of the study area under dry condition

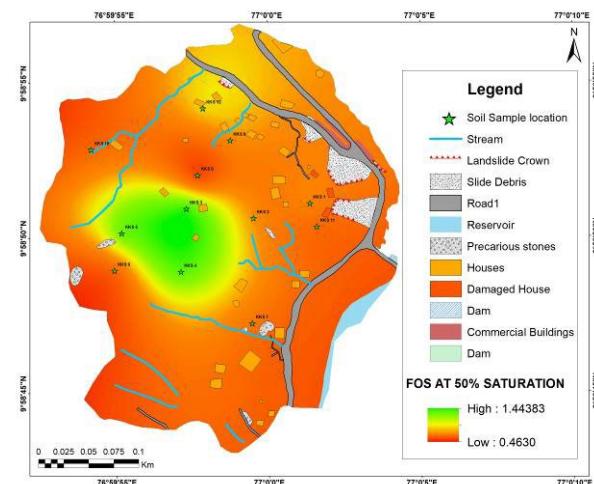
Fig. 18 Factor of Safety of the study area under 50% saturation

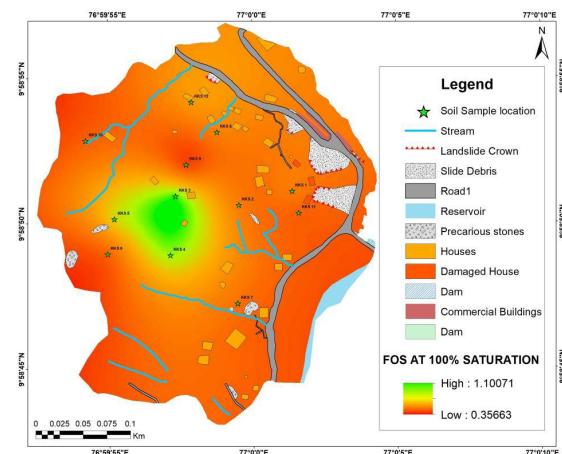
Fig. 19 Factor of Safety of the study area under 100% saturation

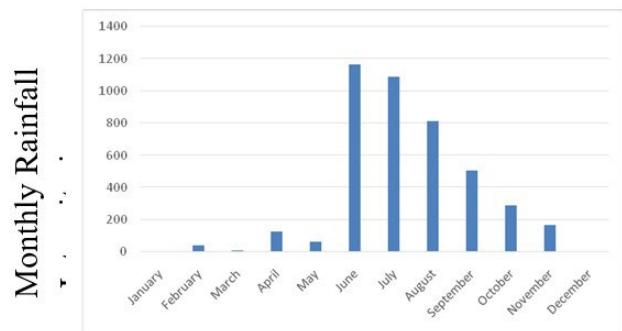
Removal of toe support without support intervention by excavation through overburden material for road construction is assessed to be the preparatory factor, whereas pore pressure increment aided by heavy rainfall is the triggering factor of the slide. The monthly rainfall in the year 2013 as recorded in Idukki Rain gauge station, which is in the vicinity of the study area shows a high rainfall in the month of June to August 2013 (Fig. 20). The intensity of rainfall in the month of June and July is relatively more when compared to August, but the landslide incidence took place in the month of August 2013. Hence, on the analysis of the daily rainfall data from June to August (Fig. 21), it is found that the failure of slope occurred as a result of continuous rainfall in August 2013.

Fig. 20 Bar diagram of monthly rainfall in 2013 as recorded in the vicinity

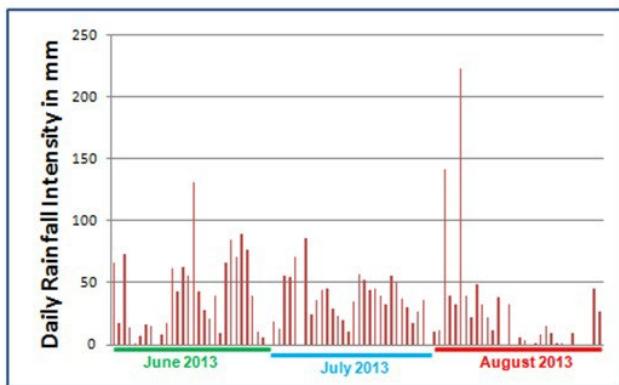
Fig. 21 Bar diagram of daily rainfall from June to August 2013 as recorded in the vicinity
