Geotechnical investigation and slope stability analysis of Kallarkutty earth slide, Idukki District, Kerala, South India

^{a,b,c} Geological Survey of India

ABSTRACT

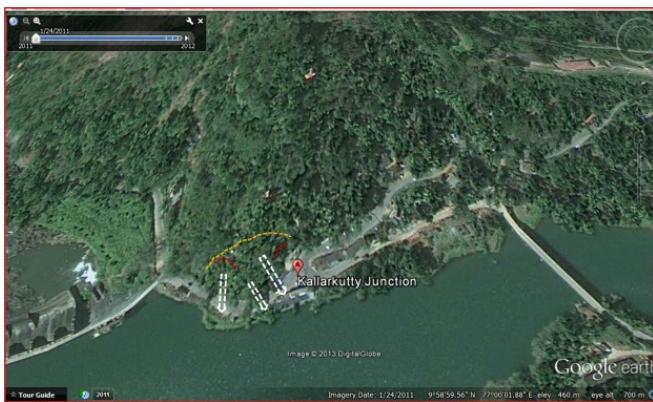
Two earth slides occurred at Kallarkutty (Fig. 1). The first slide, located at Kallarkutty Junction, measured approximately 40 m in length, 20 m in width, 2 m in depth, and had a height of about 35 m (Fig. 2). The second slide, situated northwest of the dam, had dimensions of approximately 15 m length, 15 m width, 0.5 m depth, and a height of around 10 m (Figs. 3 & 4). These incidents resulted in the development of cracks and sub-cracks extending approximately 50 m in length and 0.3 m in width behind the crown portion (Fig. 5). These cracks appeared both on the ground surface and in nearby buildings (Fig. 6). Another landslide occurred north of these incidents, measuring about 10 m in length, 10 m in width, 0.5 m in depth, and with a height of approximately 7 m. The failure mechanism of these landslides is primarily of the shallow translational type (BIS,1998).

Fig. 1 Google map showing the vulnerable slope near Kallarkutty Junction

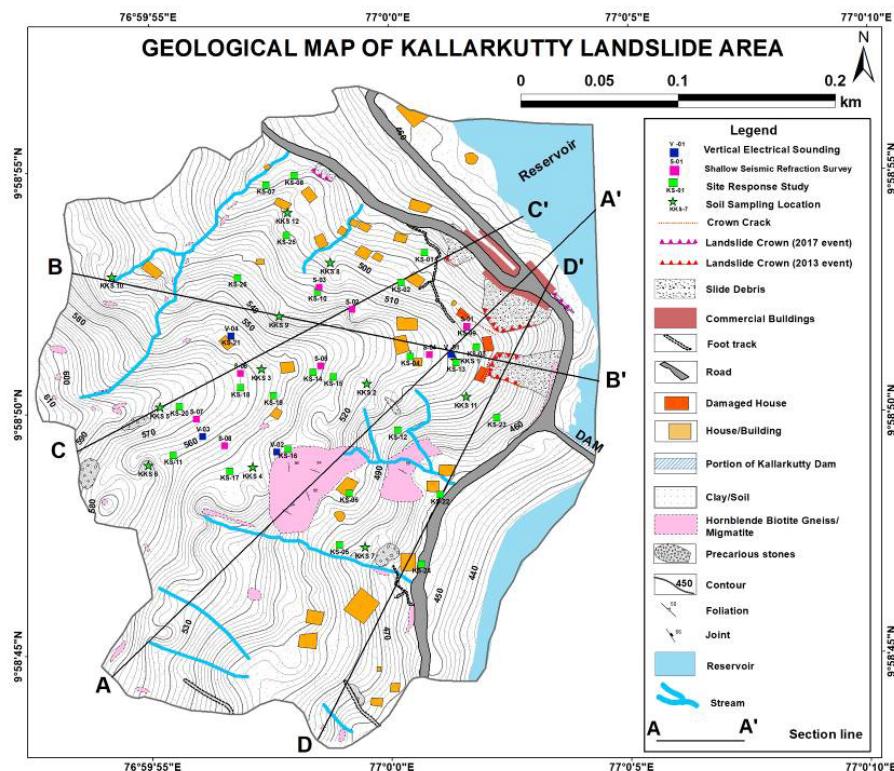
The geological map with section lines is shown in Fig. 11. Four geological sections have been prepared (Figs. 12 to 15) viz., i) A-A' – across the scar of one of the major slide, ii) B-B' – across the scar of the second major slide, iii) C-C' – across the small slide occurred just before the Kallarkutty junction, iv) D-D' – parallel to the scars.

Fig. 11 Geological map of Kallarkutty Landslide area showing the section lines

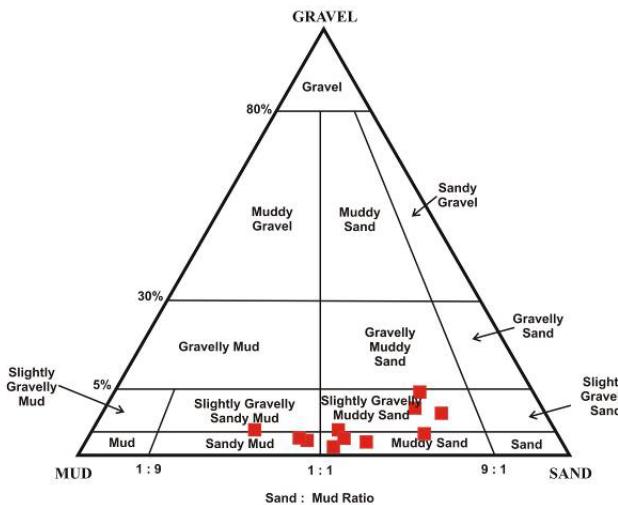
Textural characteristics of the soil material (USDA, 1971) indicates that the majority of soil samples belong to slightly gravelly muddy sand to muddy sand as represented in the ternary diagram (Fig. 16).

Fig. 16 Ternary diagram showing the textural characteristics of undisturbed soil samples
